# Combined Cycle Steam Generator Gas Side Fouling Evaluation

PHASE 1 - FINAL REPORT July 1979

Prepared Under Contract Number N0024-77-C-4366 for Naval Sea Systems Command Department of the Navy

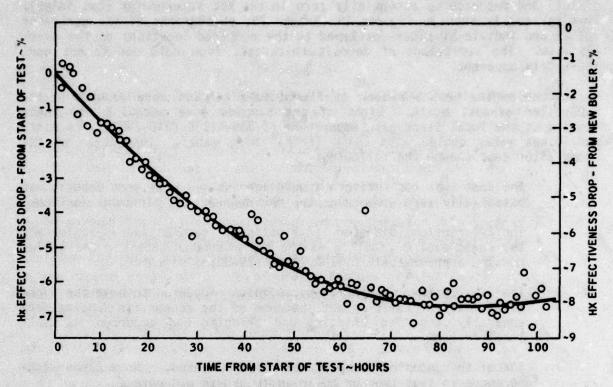
The total deterioration in the boiler module effectiveness over the length of the test was approximately 7.0 percent, as shown in Figure 18. The tests began with a deterioration of 1.4 percent from the "as built" condition. This is thought to be due mainly to fin oxidation. The test was conducted at constant boiler gas side mass flow and the pressure drop increased from a starting value of 11.7 cm (4.6 inches) of water to approximately 14.7 cm (5.8 inches) at the completion of the test. This rate of fouling was accomplished at an exhaust stack opacity of 8-10 percent which corresponds to a Von Brand smoke number = 35-40.

Figure 18. Centaur Steam Generator Module Fouling Rate

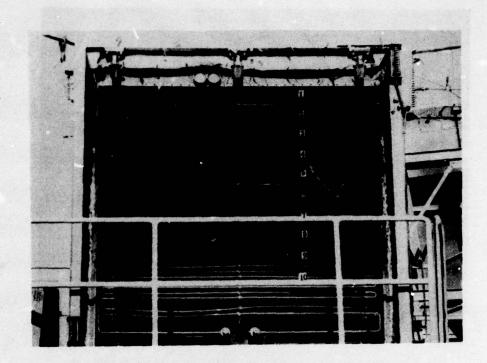
The most heavily fouled rows occurred in the preheater and although no fin bridging occurred the deposits were approximately 0.51-0.76 cm (20-30 mils) thick and thus filled approximately one half of the inter-fin spaces 2.8 fins/cm (7 fins/inch). Experience on the combustor rig at similar smoke numbers and metal temperatures indicated some bridging of the fin gaps on the 2.8 fins/cm (7 fin/inch) sections after only 12 hours of operation. This indicates a much higher fouling rate than the engine run and may be a function of the higher unburned hydrocarbon level in the combustor rig. The engine exhaust hydrocarbon levels were typically close to ambient background levels in the less than 10 ppm range while the combustor rig operated at a level of 40-60 ppm.

Figure 19. Centaur Steam Generator Module - After 105.2 Hour Test

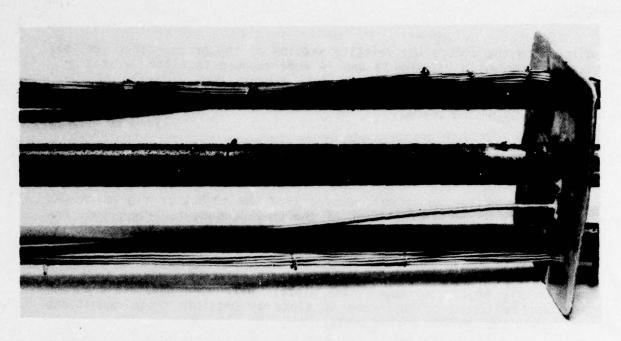
Figure 33. Portion of LM-2500 Probe Exposed to Stagnant Environment

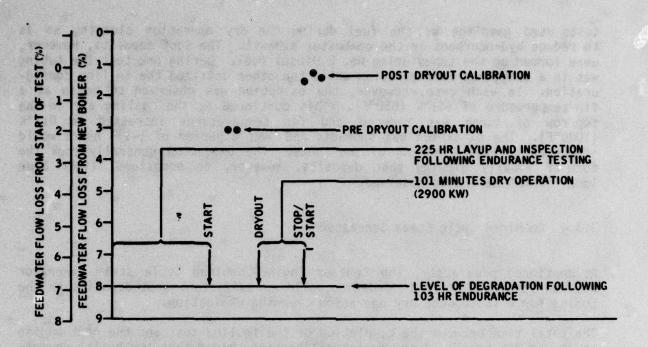
The total time between the completion of the fouling test and the next engine start was 255 hours. A pre-dryout calibration showed that the boiler performance had recovered from the eight percent deterioration at the completion of the fouling test to a three percent deterioration level. This calibration point was followed by 1.5 hours of dry boiler operation at the full load engine conditions. After an overnight cool-down period the boiler was recalibrated and the results showed that dry running had reduced the total deterioration to 1.5 percent below a clean, new unit, or only 0.5 percent below the level at the beginning of the fouling test. A summary of the dry cleaning experience is shown in Figure 36.

Figure 36. Summary of Centaur Steam Generator Dry Operation Cleaning
